# Improved Inspection Techniques for Steel Prestressing/Post-tensioning Strand

**FDOT Contract No. BDK80 977-13**  
**Final Report- Volume I**

**June 2012**

**Atorod Azizinamini, Ph.D., P.E., Florida International University**  
**Jawad Gull, Florida International University**

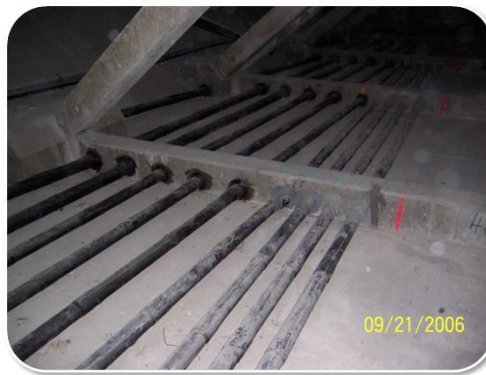
**Figure 1.4: External duct**

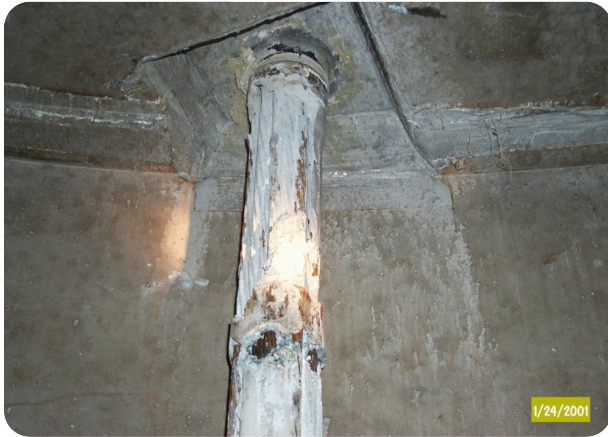
The existence of void does not necessarily translate to having corrosion at those locations. Figure 1.5(a) and Figure 1.5(b) show examples of strand conditions in the vicinity of voided areas in duct.

(a): Corrosion activity in the voided area

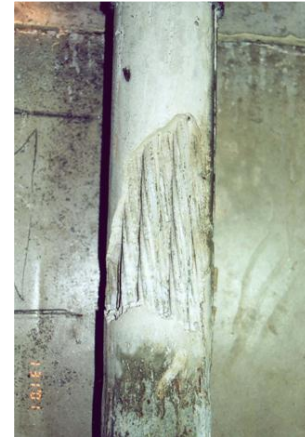
(b): Lack of corrosion activity in the voided area

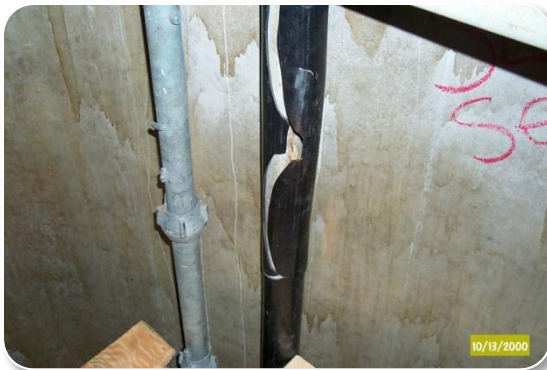
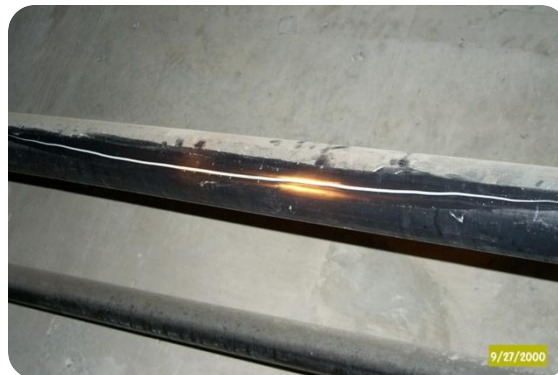
Figure 1.6 shows examples of cracking of the duct. These observed cracking are mainly related to old duct types used and were not created by grouting process. Cracking is mainly attributed to age and durability of the types of materials used. In some cases, corrosion of strands is observed at the vicinities of duct cracking. This is especially true when steel strands are exposed at cracked locations.

**Figure 1.6: Examples of types of observed cracking of ducts**

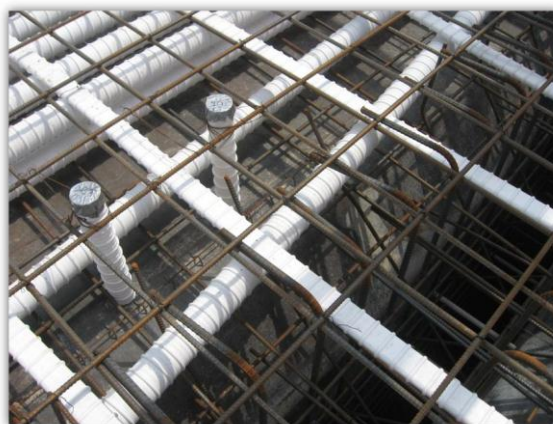
One of the major improvements from past practice is the use of plastic duct. Field performance and research has indicated that galvanized metal ducts offer little corrosion protection. Plastic ducts, on the other hand, as shown in Figure 2.1, provide an added layer of protection. Further, plastic ducts are air- and watertight. The quality of grout prior to 2000 was not good. Use of new and proprietary grout types are now the norm with many DOTs.

**Figure 2.1: Plastic ducts**

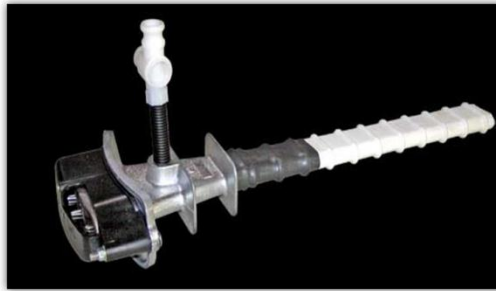
**Figure 2.2: New generation of anchorage devices**

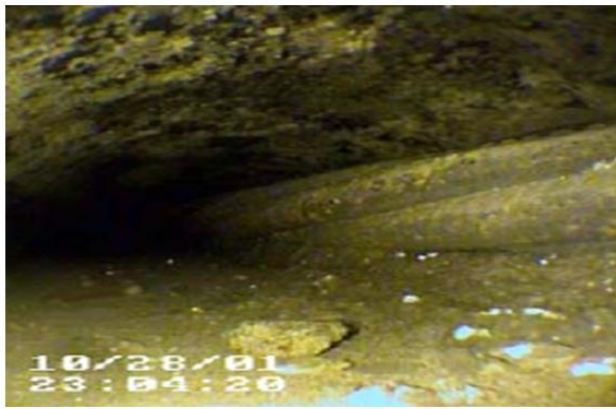
Partially grouted duct

**Figure A.1: Photos of the inside of post-tensioned duct taken by borescopes (DMJM Harris, 2003)**

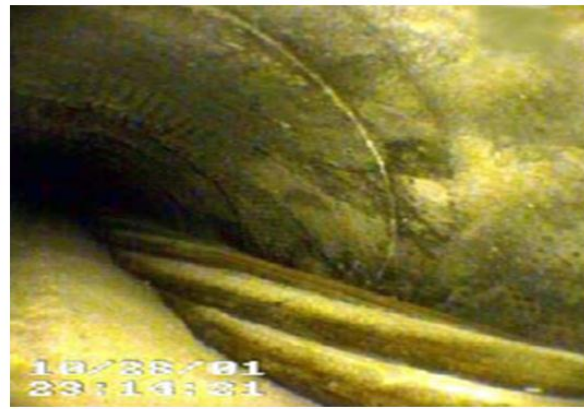
Partially grouted duct with partially exposed strands

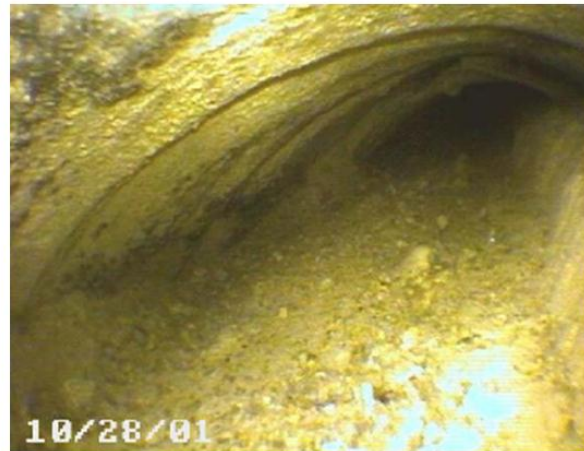
Partially grouted duct but no strand exposure

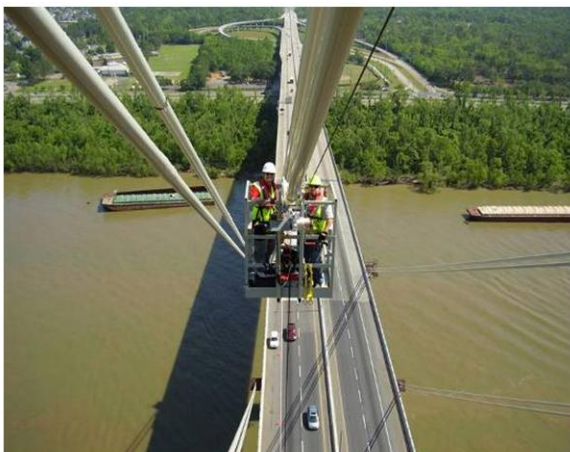
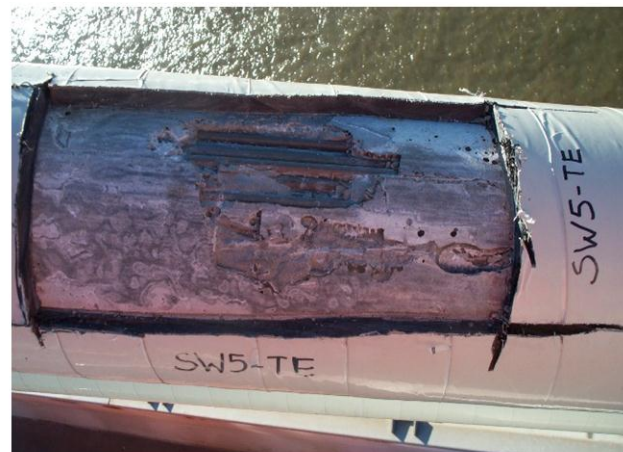
**Figure A.2: Examples of hands-on inspection of cable with a traveling buggy (left) and a dissected cable, revealing exposed steel cable wires (right)**

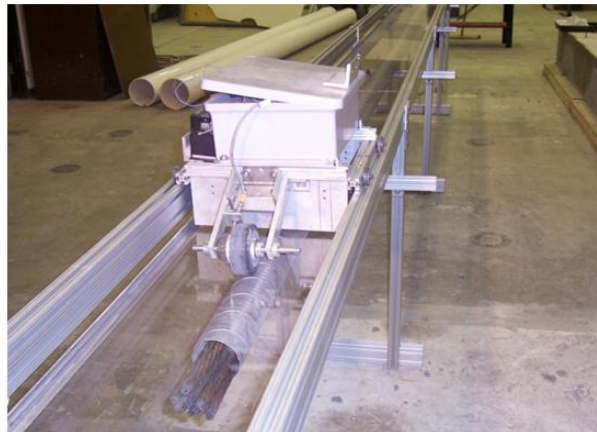
(b) Laboratory Setup

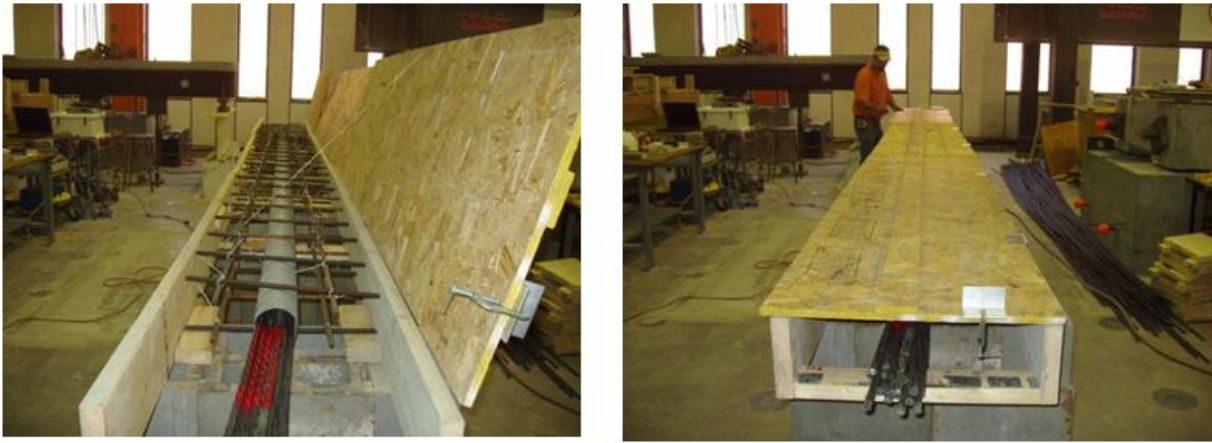
In the experiment, 19 strands are placed inside a corrugated and galvanized pipe as shown in Figure A.5.

**Figure A.5: MFL test setup used by Atorod Azizinamini**

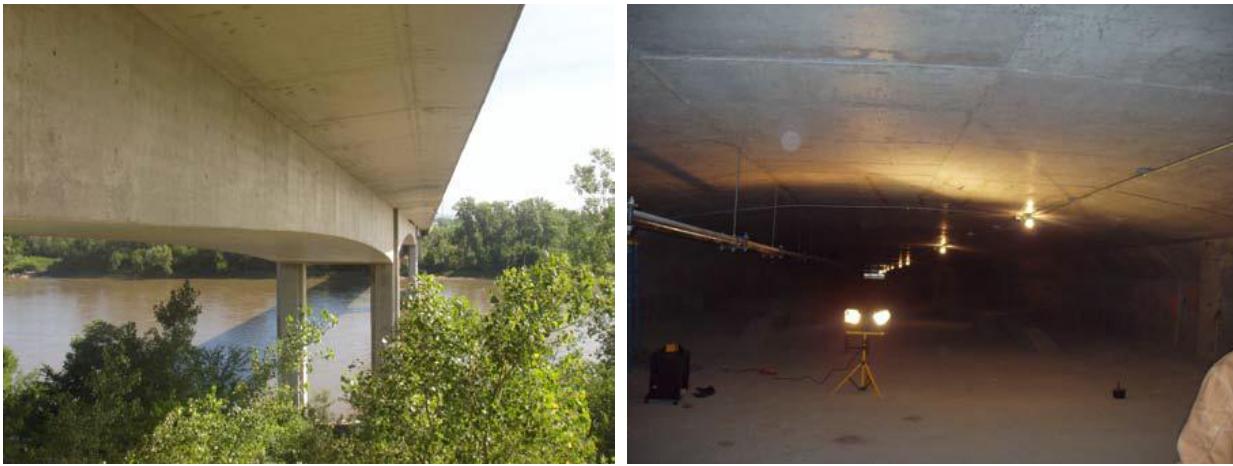
**Figure A.7: An example of major segmental post-tensioned bridge inspected by P.I.**

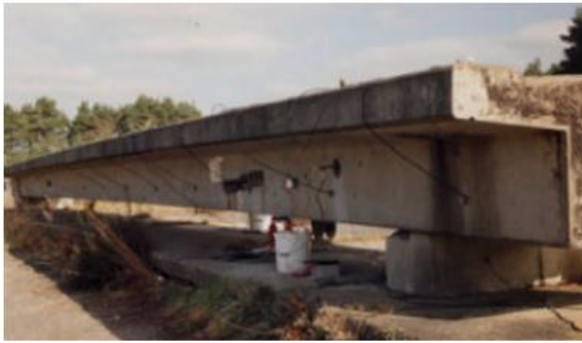
Instrumented Bank Lane Unit

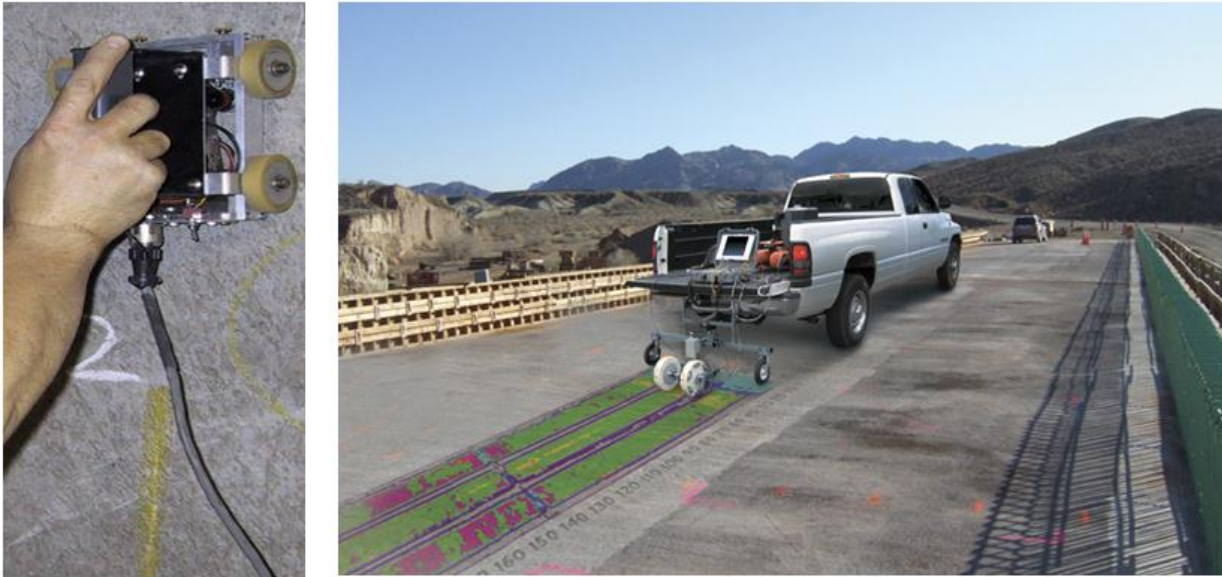
\*Note that tests can be carried out on rough unprepared concrete surfaces.

**Figure A.16: Olson impact echo scanning equipment: handheld unit (left) and vehicle mounted unit (right)**

Olson Engineering developed a scanning system based on a rolling transducer assembly incorporating multiple sensors. When the test unit is rolled across the testing surface, an opto-coupler on the central wheel keeps track of the distance. This unit is calibrated to impact and record data at intervals of 25 mm (1 inch). The maximum frequency of excitation of the solenoid impactors in the scanner is 25 kHz. The impactor in the scanning head can be replaced with one that generates higher frequencies if needed. Typical scanning time for a line of 4 m (13 ft), approximately 160 test points, is 60 seconds. In an Impact-Echo scanning line, the spatial resolution of the scan is about 25 mm (1 inch) between IE test points. Raw data in the frequency domain are first digitally filtered using a Butterworth filter with a band-pass range of 2 kHz to 20 kHz. Picks of dominant frequency were performed on each spectrum and an Impact-Echo thickness was calculated based on the selected dominant frequency. A three-dimensional plot (in either color or grayscale) of the condition of the tested specimens can also be generated by combining the calculated Impact-Echo scan lines. Figure A.15 shows the Olson impact echo scanning equipment, both handheld and vehicle mounted units.

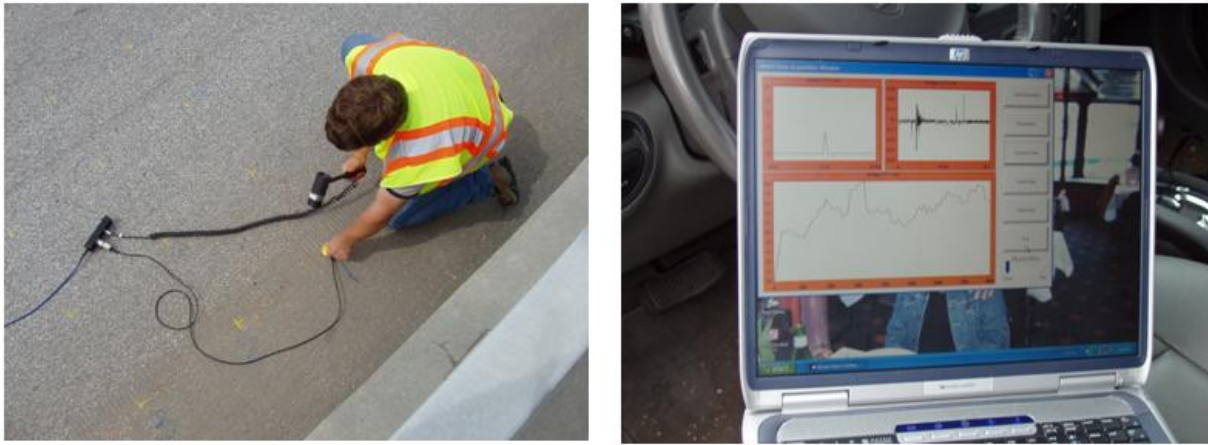
**Figure A.19: Impulse response test equipment (left) and data acquisition software showing sensor outputs and computed mobility signal**

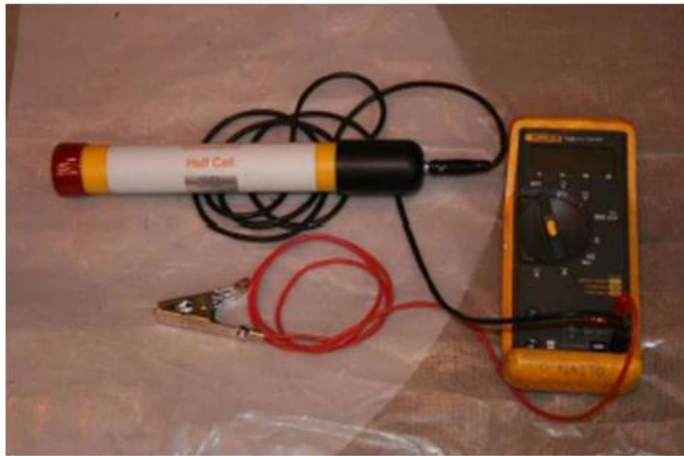
Half-Cell Electrode with Multimeter

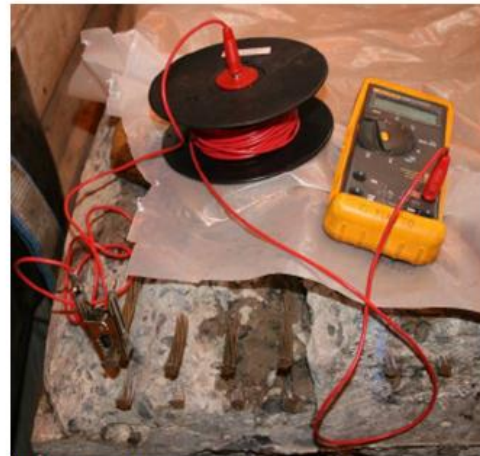
Electrical connection to strands

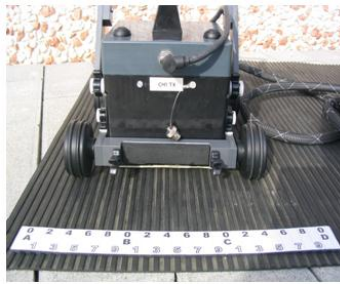
**Figure A.36: IDS Aladdin radar on test pad**
